# Manhole Inspection Summary

Manhole # S21WW1032MH

Insp Date: **12/19/06 10:54 AM**

**Location** Address: **5106 CROSS KEYS RD** Cross Street: **HAMLET HILL RD**

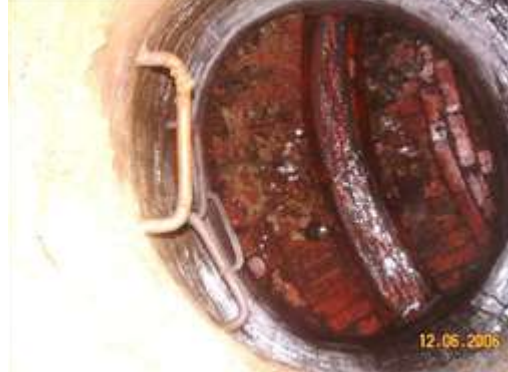
Top View

**Bench** ☒ Exists Material: **Brick** ☐ Parged ☒ **Debris** (not Condition related)  
Condition: ☒ Sound ☐ Cracked ☐ Root Intrusion ☐ Deteriorated ☐ Leaks ☐ Debris

**Surcharge** ☒ **Evidence Of Surcharge** Depth: **1** (ft.) ☐ Active Surcharge Present

Evidence of surcharge - Bench debris.

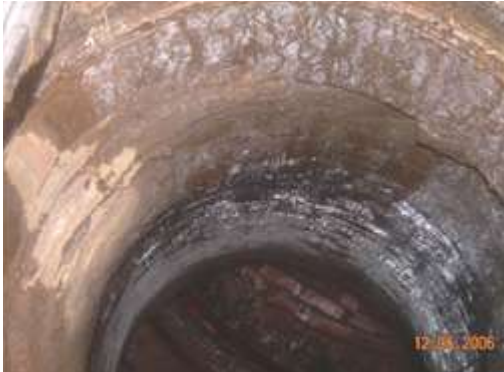
Defect

**Frame** Offset: **1** (in.) Condition: ☐ Sound ☐ Cracked ☒ **Leaks**

**Chimney / Frame Adjustment** ☒ Exists Material: **Brick** ☐ Parged Height: **18** (in.)  
Condition: ☐ Sound ☐ Cracked ☐ Root Intrusion ☐ Loose Brick ☒ **Deteriorated**  
Infiltration: ☐ None ☒ **Joint** ☐ Cracks ☐ Mortar ☐ Roots ☒ **Wall**

**Corbel** Material: **Brick** ☐ Parged Type: **Concentric/Eccentric**  
Condition: ☒ Sound ☐ Cracked ☐ Root Intrusion ☐ Loose Brick ☐ Deteriorated  
Infiltration: ☐ None ☐ Joint ☐ Cracks ☐ Mortar ☐ Roots ☒ **Wall**

**Barrel** Material: **Brick** ☐ Parged  
Shape: **Circular** Diameter: **48** (in.) Length: (in.)  
Condition: ☒ Sound ☐ Cracked ☐ Root Intrusion ☐ Loose Brick ☐ Deteriorated  
Infiltration: ☐ None ☐ Joint ☐ Cracks ☐ Mortar ☐ Roots ☒ **Wall**

Frame leaks. Adjustment deterioration and infiltration. Corbel and Barrel infiltration.

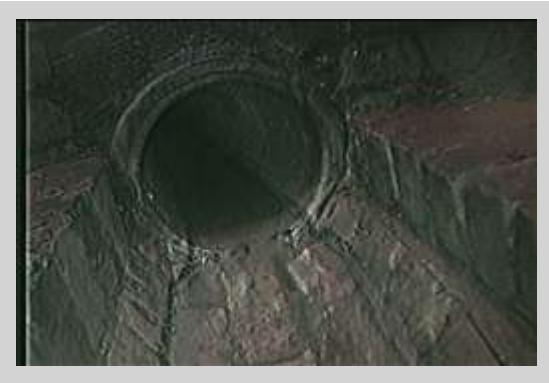
### 8 in. Circular Gravity Sewer Pipe Out @ 12 O'Clock

**Channel** Material: **Brick** ☐ Parged ☐ Debris (not Condition related)  
Channel Exposure: **Fully Open** Junc Dist: **0** nearest .5 ft. Azimuth:  
Condition: ☐ Sound ☐ Cracked ☐ Root Intrusion ☒ **Deteriorated** ☐ Leaks ☐ Debris

Channel deterioration.

Infiltration: **None** Pipe Seal Cond: **Cracked**

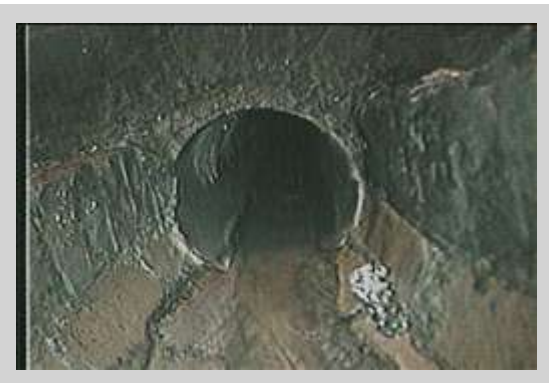
### 8 in. Circular Gravity Sewer Pipe In @ 5 O'Clock

Infiltration: **None** Pipe Seal Cond: **Cracked**
